## CASE STUDY

# Greenbank Terotech enhancing engineering performance

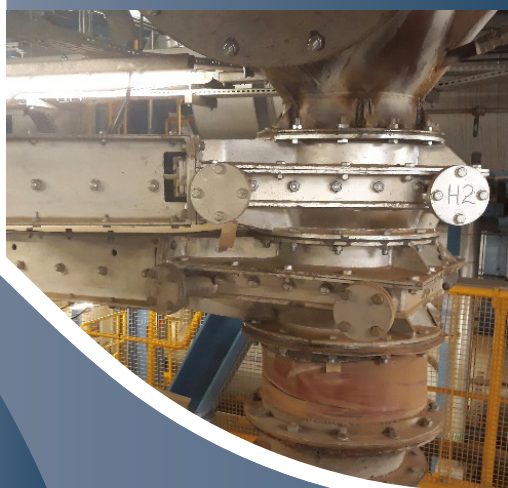
The chutework design did not account for the oversize and tramp materials, which were collecting in the discharge chutes causing the blockages, and the ash system design did not include ash crushers.

Arrangement before crusher installation:

Greenbank approached the customer and proposed the addition of a UCC Excen 460 crusher into each of the discharge chute legs to eliminate the blockage problem. The crusher would be installed into the chutework at the position where the blockages had arisen.

Greenbank also made modifications to the chutework feeding the crusher to promote material flow. Due to the configuration of the fluidised bed and discharge chute arrangement, the crusher would be operating in a column of material, rather than a free-flowing feed. To facilitate this, the crusher would be programmed for pulse operation, rather than continuous running.

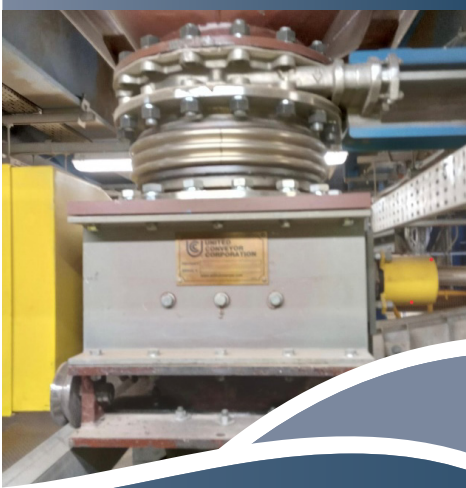
Since a successful trial run in 2020, the crushers have been in full operational mode and the chute blockages have been eradicated removing the need for regular manual intervention.

Excen 460 Crusher in operation:

UCC's Durite material was selected for the crusher cams to give extended wear life in this hot, aggressive application. The crusher would also be mounted on rails to enable easy access to the crusher internals for routine maintenance. Initially Greenbank installed a single crusher on the most problematic discharge chute leg to test performance.
