Sewer Rebuilding Solution for Flood Damage Repairs

underneath Pařížská Street Prague

Sewer repair and reconstruction

underneath Pařížská Street

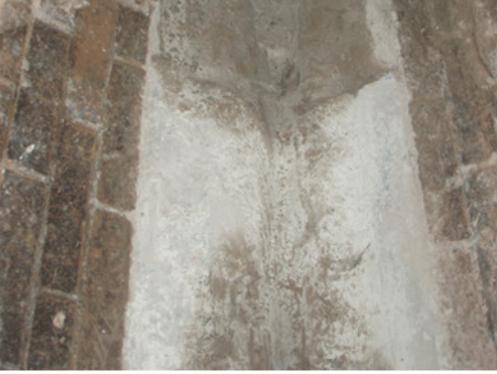
phase 1
The original worn lining system
at the bottom of the sewer.

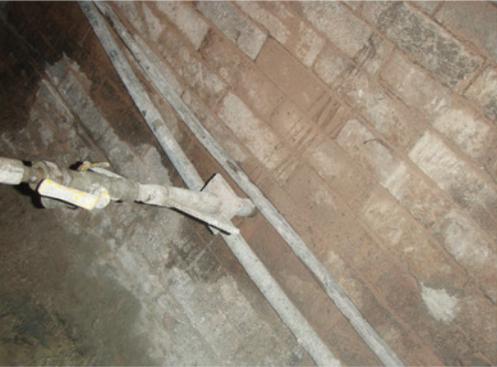
phase 2
Filling in the voids behind the original lining
with new mortar.

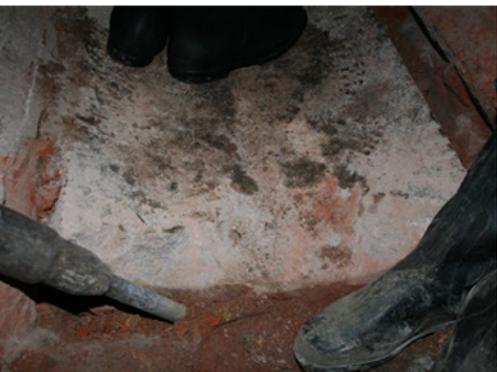
phase 3
Removing the original bottom gutter section.

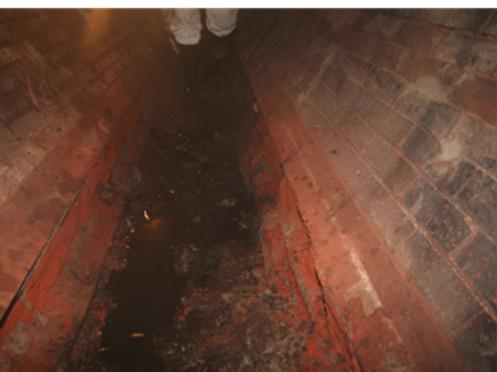
phase 4
Excavating original bottom liners and
2 rows of bricks.

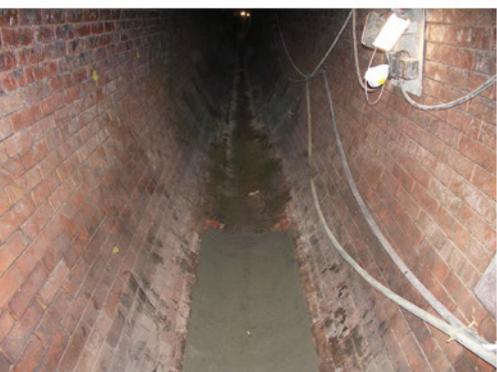
phase 5
Back filling in the voids with concrete where
damaged gutters and bricks were removed.

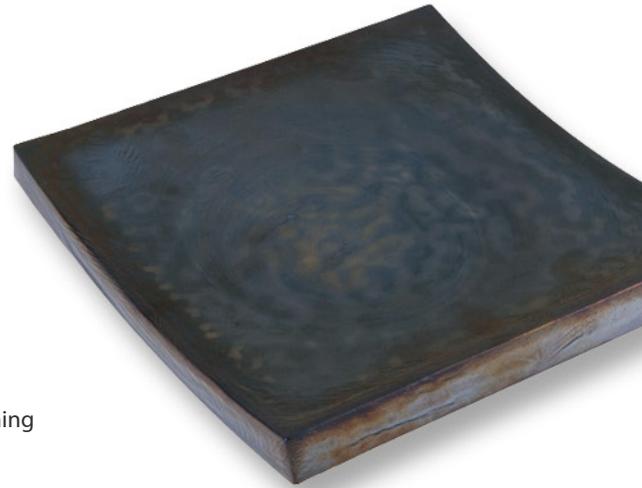
phase 6
Bedding in new cast basalt liners using special purpose mortar.

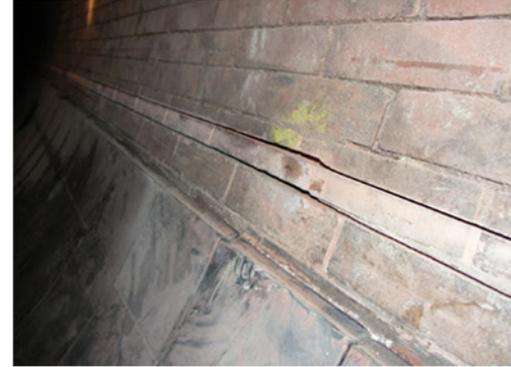
phase 8
Groove cut into existing lining ready for finishing L shaped basalt liner.

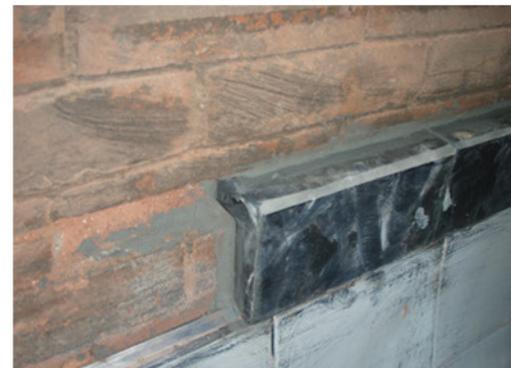
The bottom section replaced with basalt lining system.
